Optimization of the Rehabilitation of Concrete Buildings Based on Their Dynamic Properties

Original Research Article

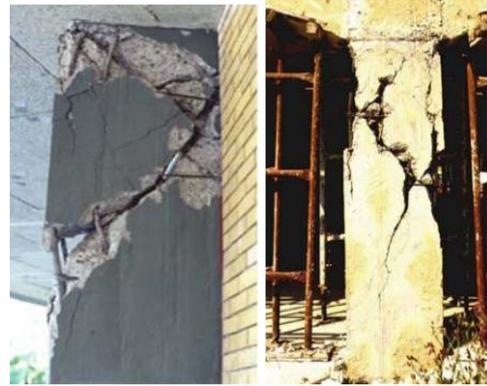
Fig. 1. Shear failures of columns [6]

Severe structural damage: It is the most critical state that can suffer the structure, are located cracks of more than 1.0 mm in width in concrete elements, the detachment of the coating in columns, the crushing of concrete (Fig. 1), the breakage of stirrups and the buckling of the Reinforcement in columns as in concrete wall, cracking of flat slabs around the columns, the collapse in columns of more than 1: 100 of its height and the collapse of the building of more than 1: 100 of its height.

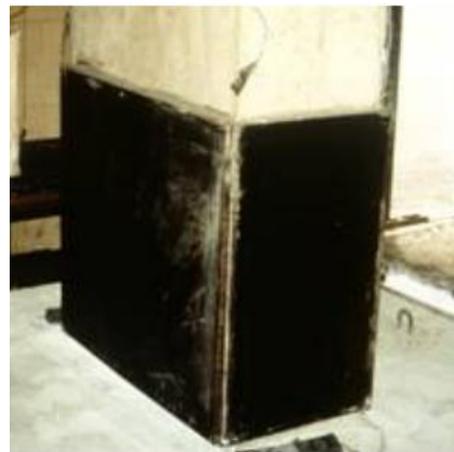
Fig. 2. Steel jacketing of a column [7]

In the seismic rehabilitation of structures, the lateral resistance is often provided by the modification and/or addition of elements only in certain parts of the structure like in the case of jacketing of these elements with either steel (Fig. 2) or concrete (Fig. 3). The remaining elements of the structure are usually not reinforced.

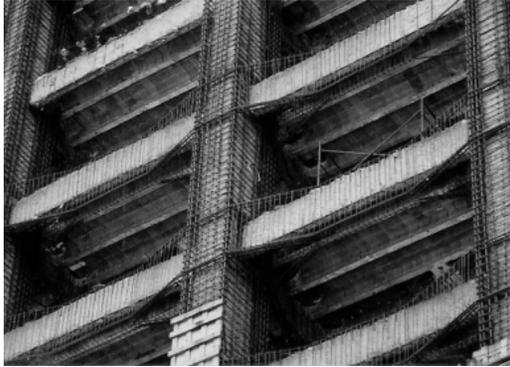
Fig. 3. Concrete jacketing of columns and beams [8]
